Manhole Inspection Summary

Manhole # S51M__009MH

Insp Date: **4/3/08 10:39 AM**

Location Address: **946 s. kenwood ave**

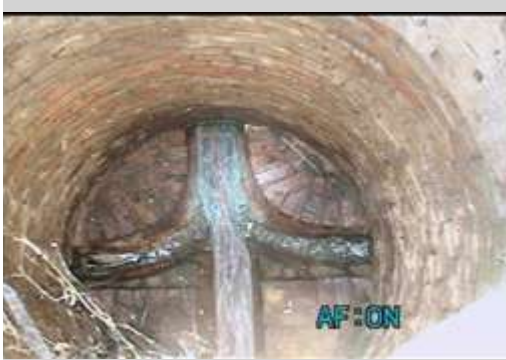
Top View

Condition: **Cracked**

Condition: ☐ Sound ☒ **Cracked** ☐ Root Intrusion ☐ Loose Brick ☐ Deteriorated

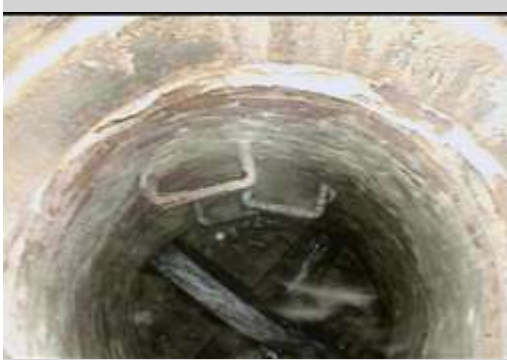
Defect 1

Count: **4** Missing: **0** ☒ **Corroded**

steps

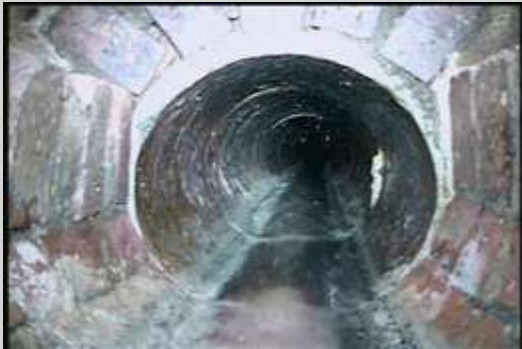
12 O'Clock Outflow

10 in. Circular Gravity Sewer
Pipe Out @ 12 O'Clock

Pipe Material: **Clay** ☐ Pipe Lined

Invert Depth: **9.30** (ft.) Flow Characteristics: **Fast**

Infiltration: **None** Pipe Seal Cond: **Unknown**

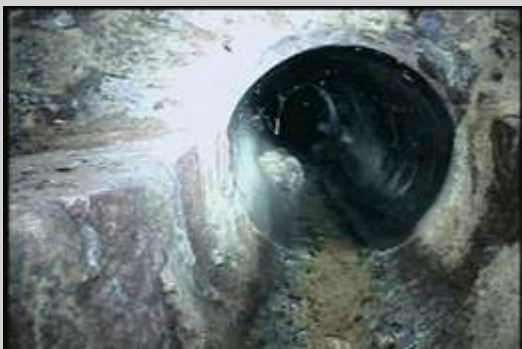
3 O'Clock Inflow

10 in. Circular Gravity Sewer
Pipe In @ 3 O'Clock

Pipe Material: **Clay** ☐ Pipe Lined

Invert Depth: **8.83** (ft.) Flow Characteristics: **Fast**

Infiltration: **None** Pipe Seal Cond: **Unknown**

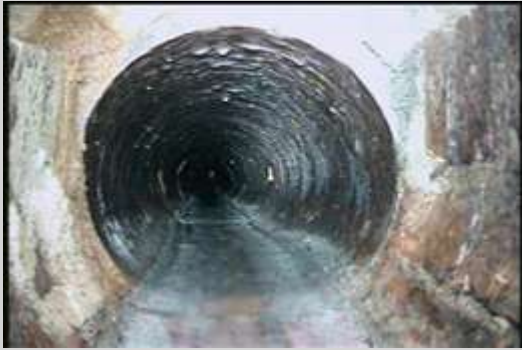
6 O'Clock Inflow

10 in. Circular Gravity Sewer
Pipe In @ 6 O'Clock

Pipe Material: **Clay** ☐ Pipe Lined

Invert Depth: **9.13** (ft.) Flow Characteristics: **Fast**

Infiltration: **None** Pipe Seal Cond: **Unknown**

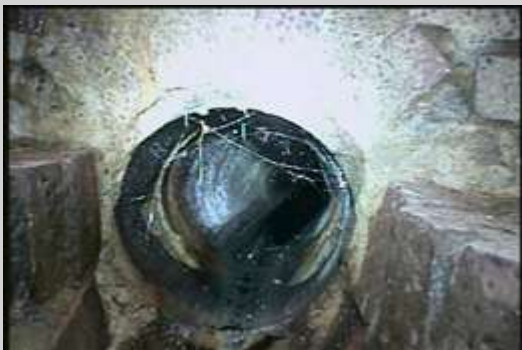
9 O'Clock Inflow

8 in. Circular Gravity Sewer
Pipe In @ 9 O'Clock

Pipe Material: **Clay** ☐ Pipe Lined

Invert Depth: **8.88** (ft.) Flow Characteristics: **None**

Infiltration: **None** Pipe Seal Cond: **Unknown**
